**Santa Monica Mountains National Recreation Area
Visitor Center, King Gillette Ranch**

Addenda #2 - April 8, 2009

INVENTORY AND CONDITION ASSESSMENT
BUILDING 8 - GILLETTE RANCH

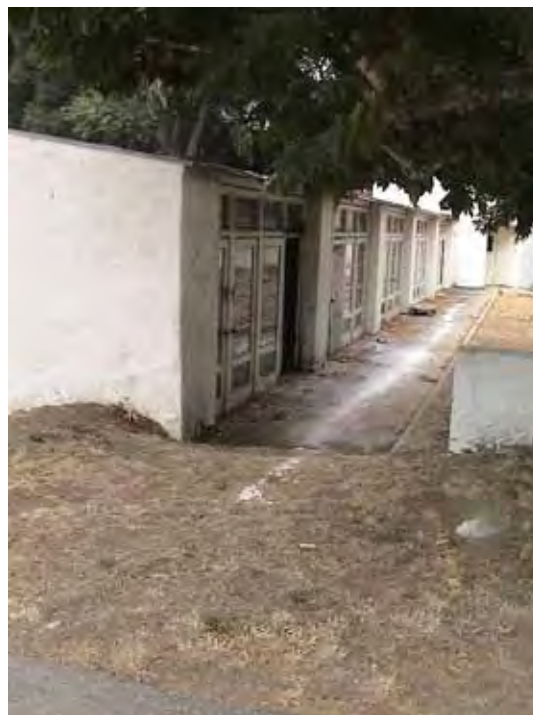
#14 – Exterior Drainage Issues

| Corrective Action | <p>Fill and restore areas damaged by abortive alteration.</p> <p>Replace rotted half-logs at bottom of windows into Hay Loft; provide flashing and seal around penetration of beam penetration above same windows.</p> <p>Exterior wrought iron railing and steps up to Hay loft are in very good condition.</p> <p>Provide "moat" to divert surface drainage around building. Provide new sump pump at court.</p> |

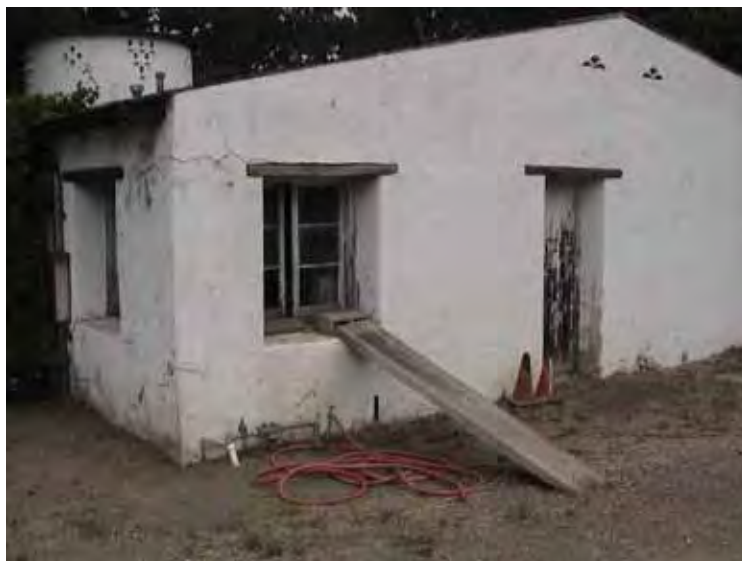
#16 – Exterior and Water Service

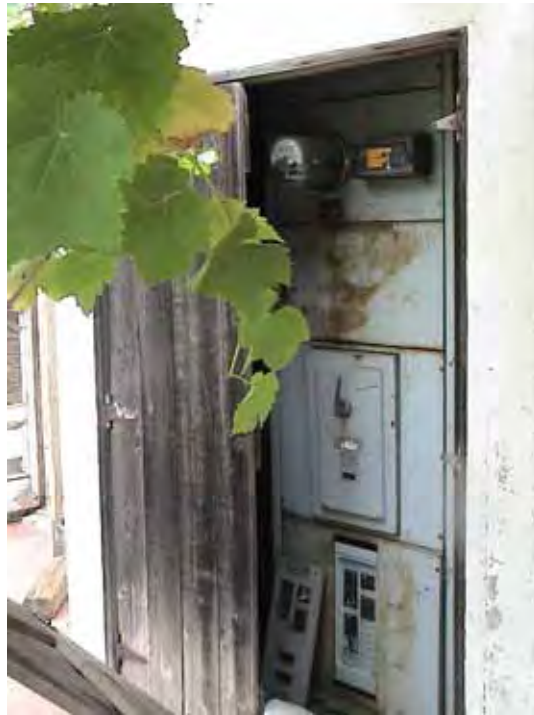
#19 – Electrical Service

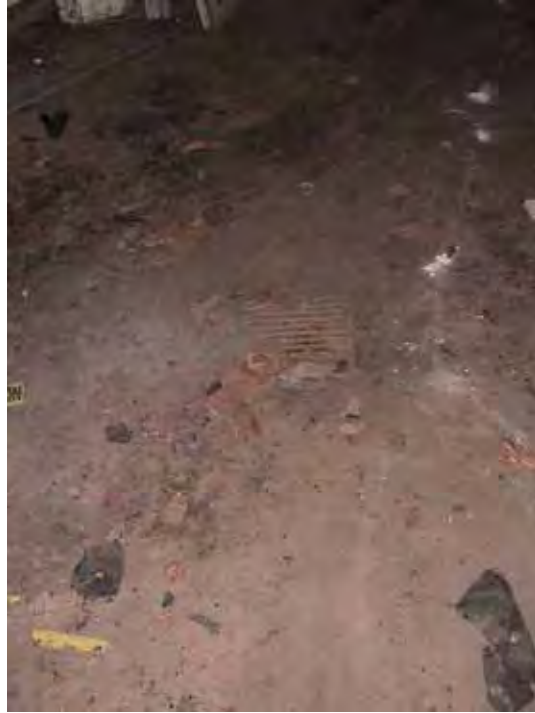
#41 – Floor Drain

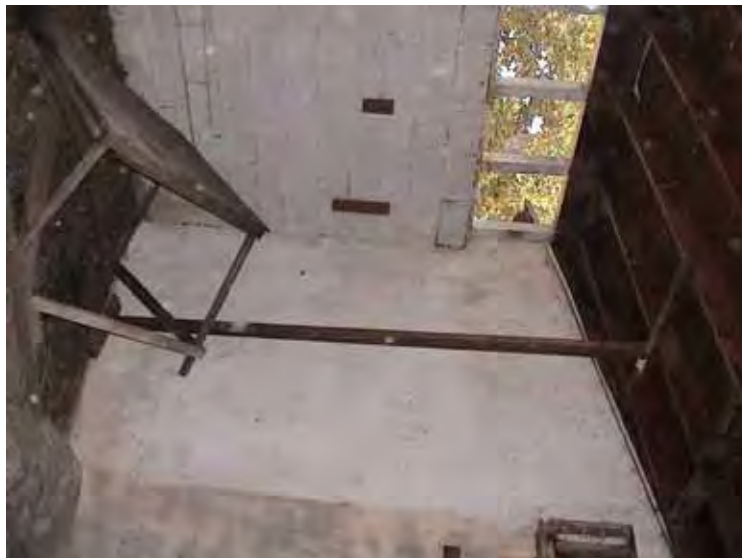
#46 – Exposed Ceiling Rafters in Lean-to Addition

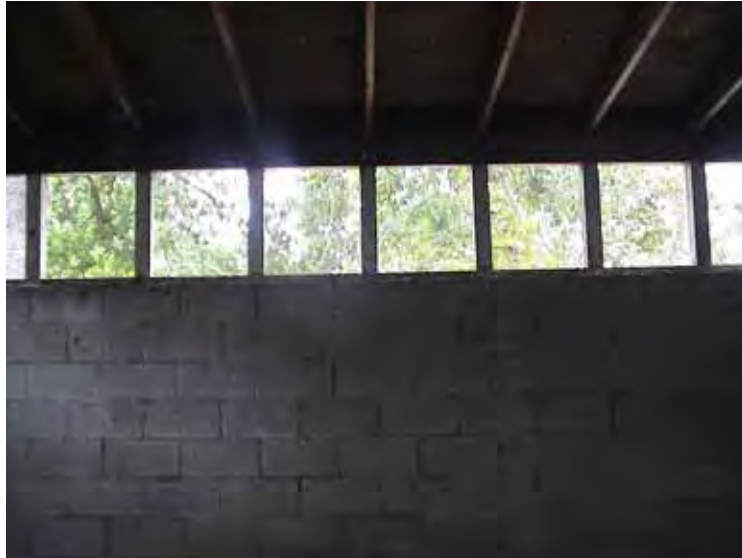
#47 – Exposed Ceiling Rafters in Lean-to Addition

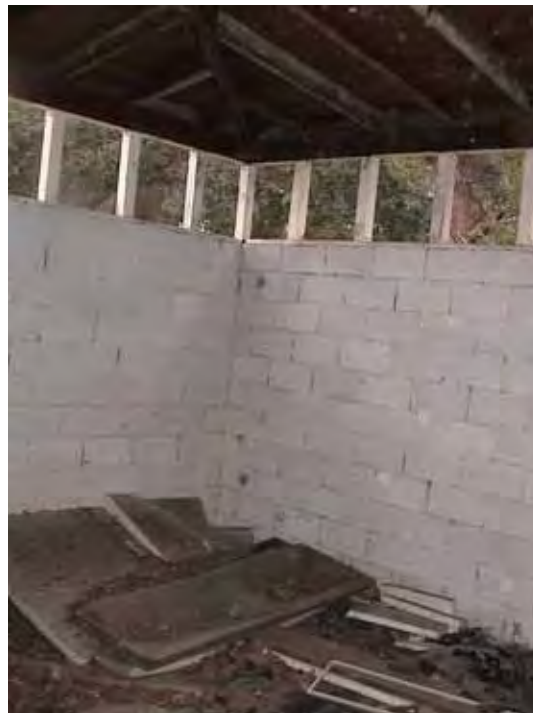
#48 – Exposed Ceiling Rafters in Lean-to Addition

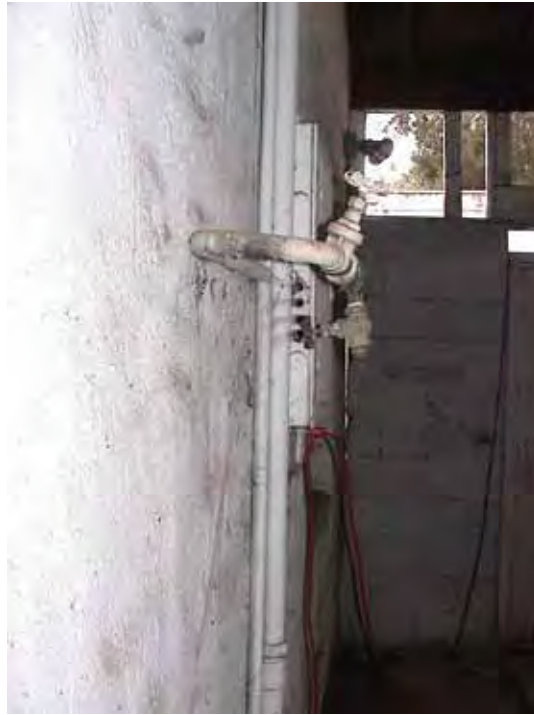
#49 – Water Service

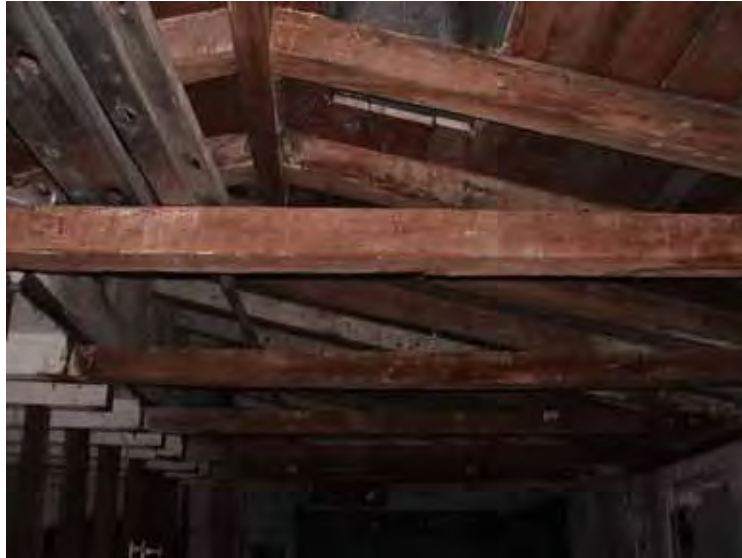
#54 – Exposed Ceiling Rafters-Stables

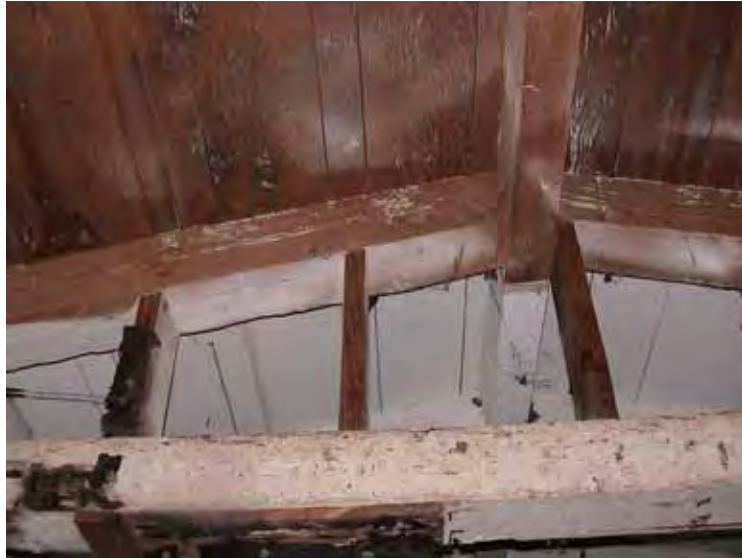
#56 – Exposed Ceiling Rafters

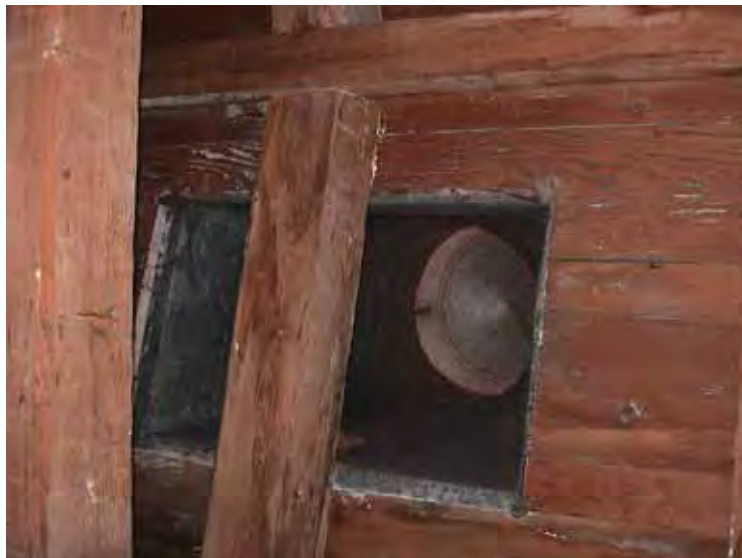
#57 – Flue Stack

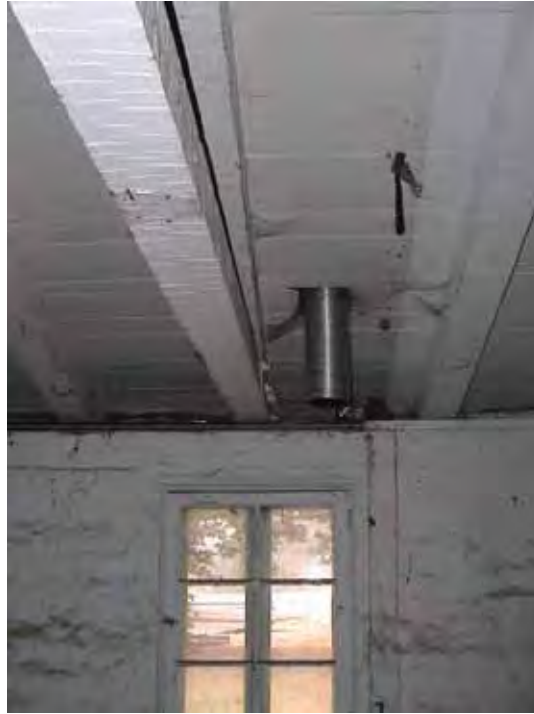
#58 – Vent Ductwork Through Roof-Stables

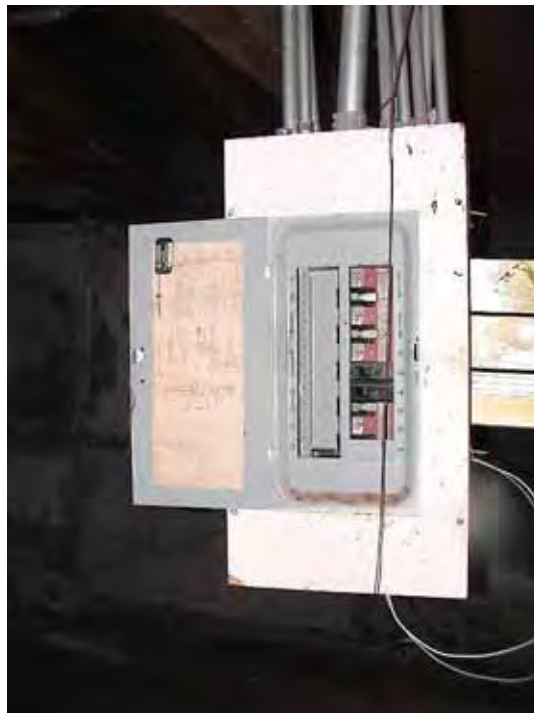
#59 – Unsupported Electrical Panel

| Condition | Panels are in fair condition and one (1) sub-panel is supported only by conduct (Photo #59) |

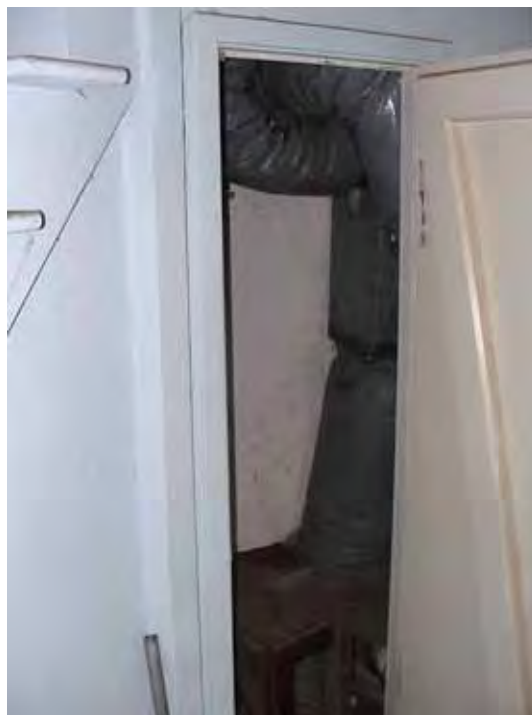
#65 – HVAC Ductwork in Hay Loft Closet

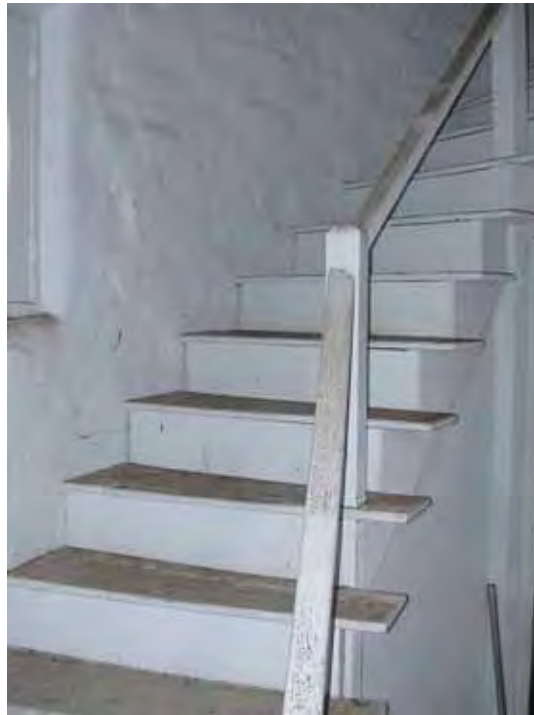
#66 – Interior Stairway in Hay Loft

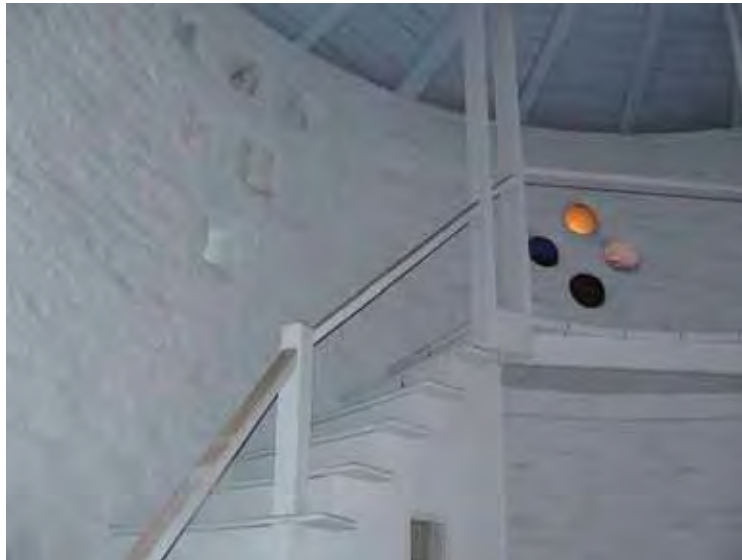
#67 – Interior Stairway in Hay Loft

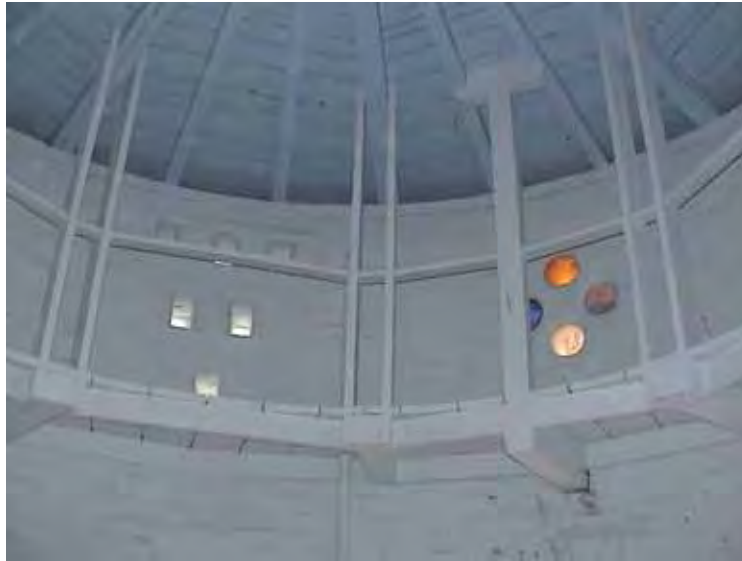
#68 – Interior/Elevated Catwalk in Hay Loft

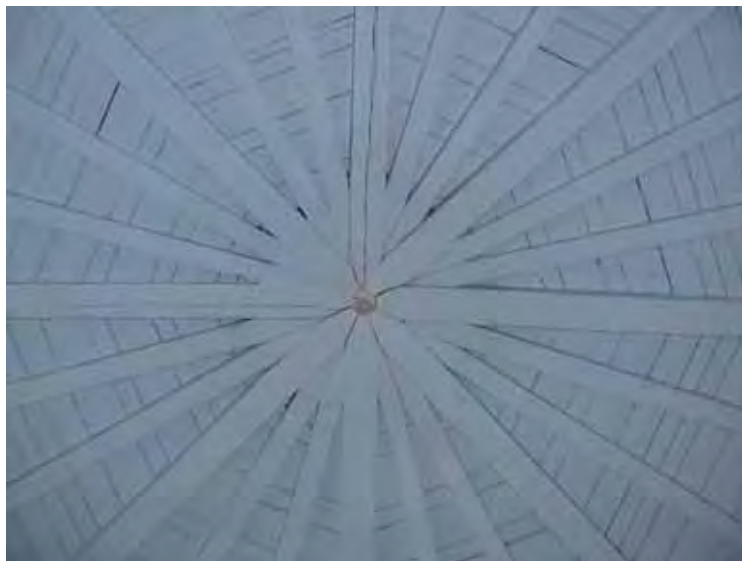
#69 – Dome Ceiling in Hay Loft

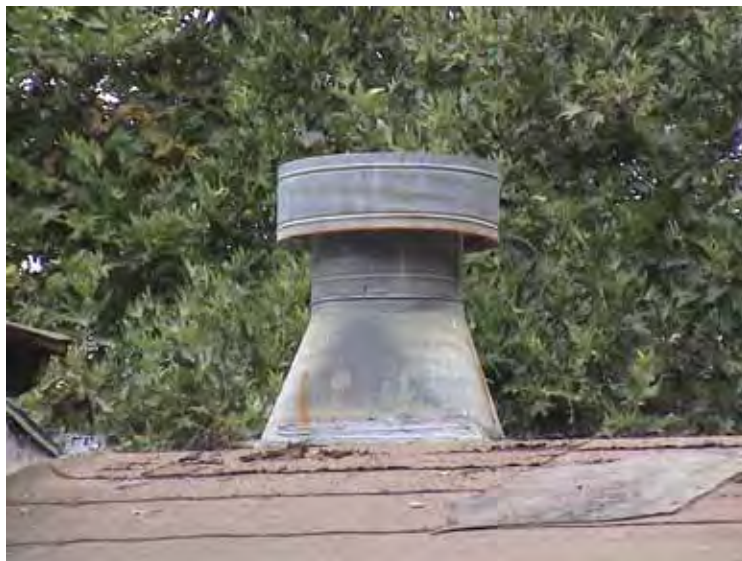
#71 – Flue Stack
